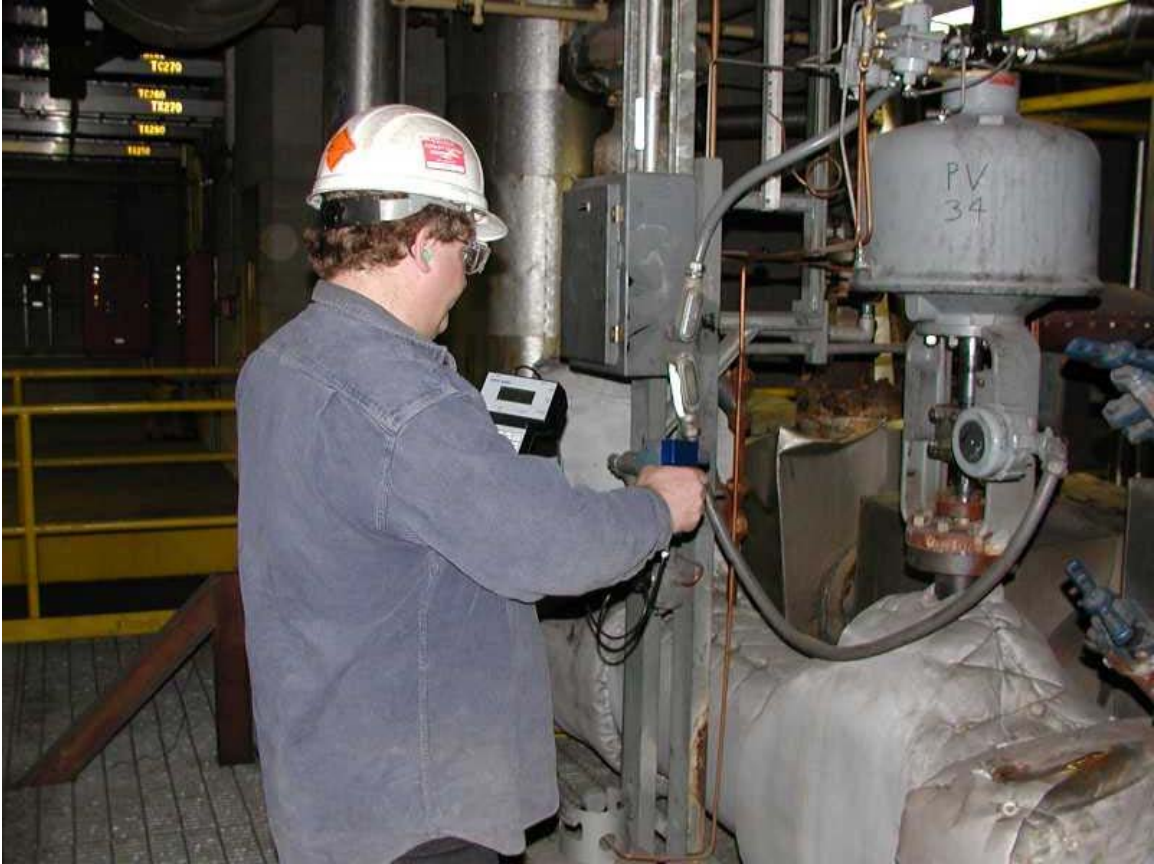
The AED-2000 being used with a 40 kHz airborne probe to find a steam leak at a piping valve. There were several leaking valves in this area. With the “filter out” selection, some of these would overlap and make the process of locating an individual leak more difficult. With the “filter in” selection, the location of each individual leak was more distinct and easier to pinpoint. You can hear the difference in the audio output by double clicking on the icons below. The probe is being scanned back and forth across the leaking valve.
