Termite damage discovered in bathroom windowsill with SP-1 low frequency probe

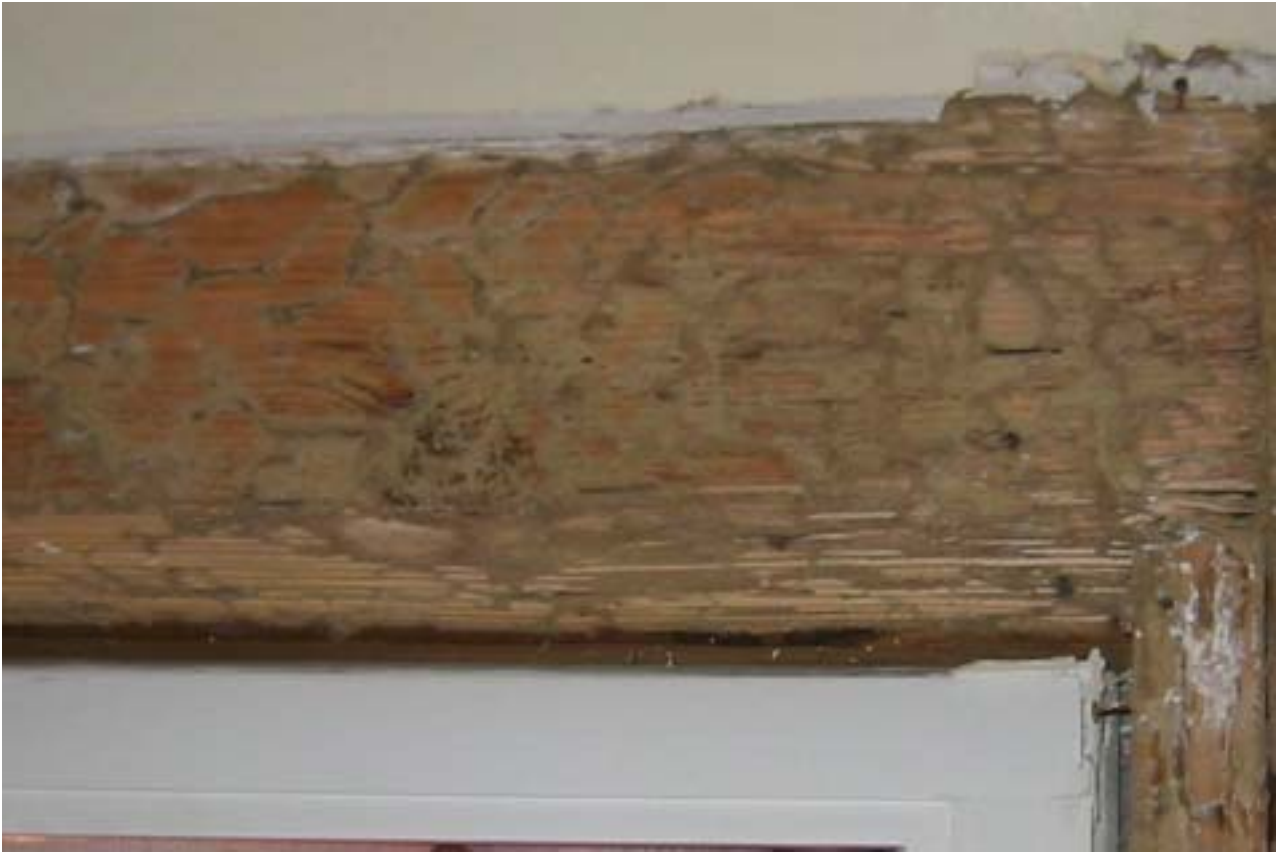
When the windowsill was opened for repairs several months later, the results are evident in the photo above. The mud tubes of subterranean termites are clearly visible on the window framing. To listen to the sound that was recorded from the AED-2000 audio output, click on the icon below
